**Re: Cowichan Bay Fire Improvement District
Fire Hall Seismic Assessment**

Cowichan Bay Improvement District requested that Herold Engineering Limited provide a seismic review of the Cowichan Bay Fire Rescue Centre. The purpose of this review is to establish the expected performance of this building in a code level seismic event and make recommendations for possible upgrading work that may be necessary.

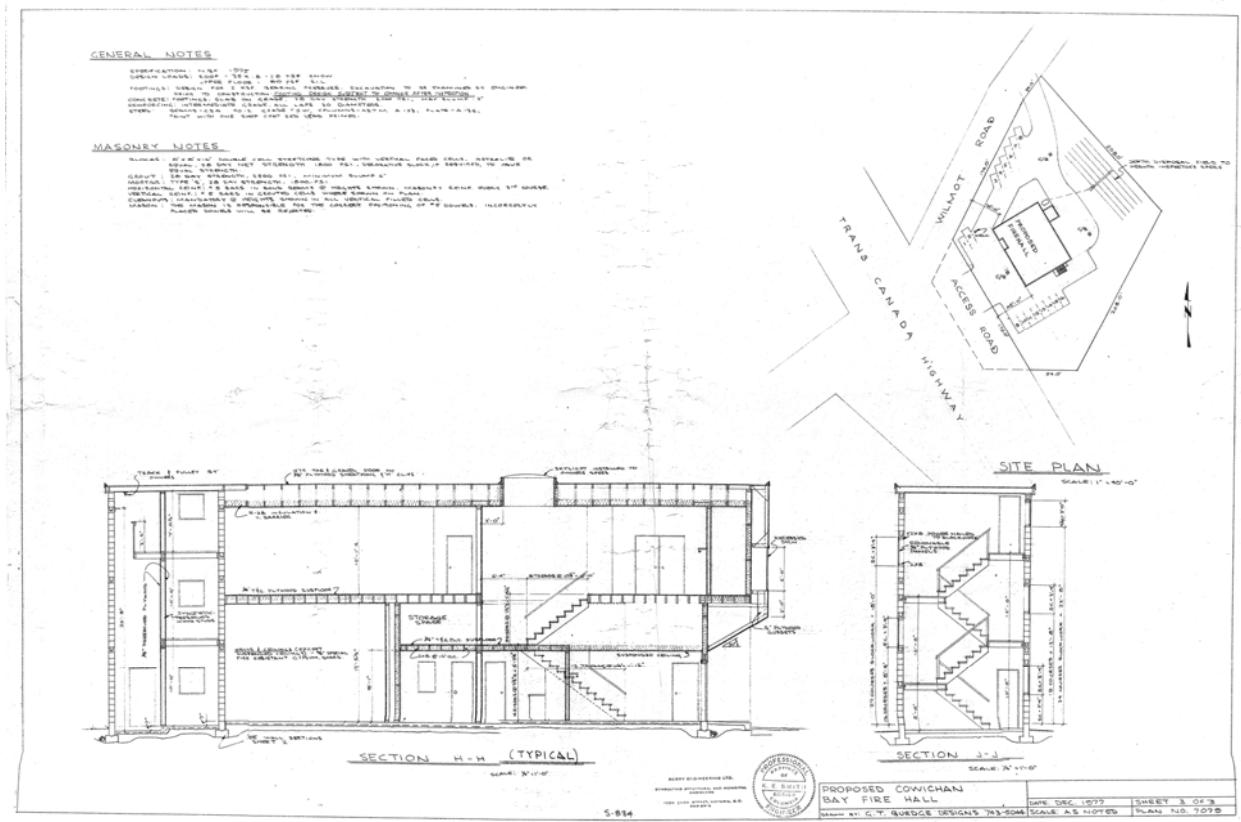
The apparatus bay is constructed in masonry with a post and beam steel structure supporting the wood floor above. The hose tower is constructed in masonry and is built to the rear of the apparatus bay. Adjacent the apparatus bay is the wood frame storage and office areas also supporting a wood floor above.

The second floor comprises 2x12 floor joists spanning over the post and beam frames in the apparatus bay and the 2 x 6 stud walls in the administration and storage areas. Walls at the second floor are 2 x 6 studs, which support parallel-chord timber roof trusses. The exterior walls, floor and roof are sheathed in 3/8" plywood.
